## Exponential Business and Technologies Company

### Fatigue Fracture of a Ti-6Al-4V Rod

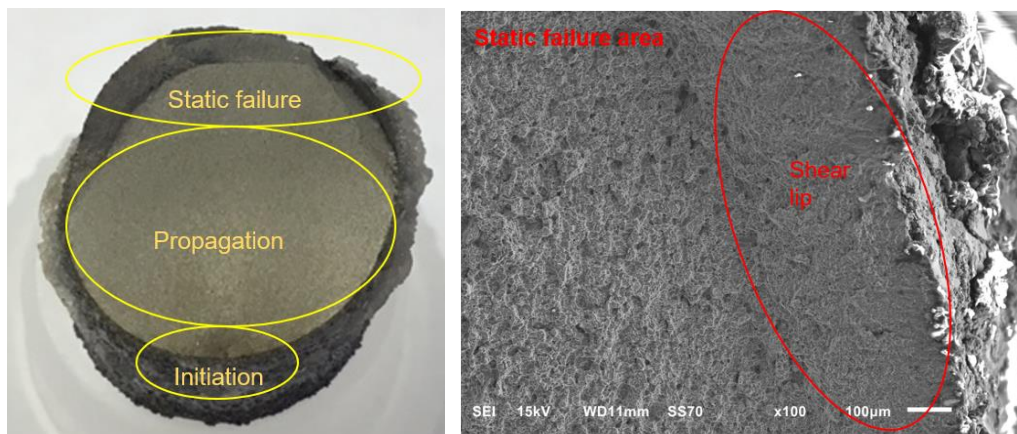
This analysis describes the fatigue fracture of a rod composed of Ti-6Al-4V, a material widely used in medical implants due to its excellent biocompatibility. Figure 1 is an image of the fracture surface of the Ti-6Al-4V rod. On the outer surface of the rod there is a rough Ti-V coating which is likely present to improve bone integration. The cross section of the fracture surface includes three different regions corresponding to the three stages of fatigue failure. The crack initiated at the surface of the rod and then slowly propagated to cover approximately two-thirds of the cross section. When the crack reached a critical size, final static failure occurred. As the crack grew closer to the edge, the fracture mode changed from a plane-strain mode (mode I) to a plane-stress mode (mode II), resulting in the formation of shear lips.

Figure 1. (Left) The fracture surface images of the Ti-6Al-4V rod, (right) shear lip in the static failure area.

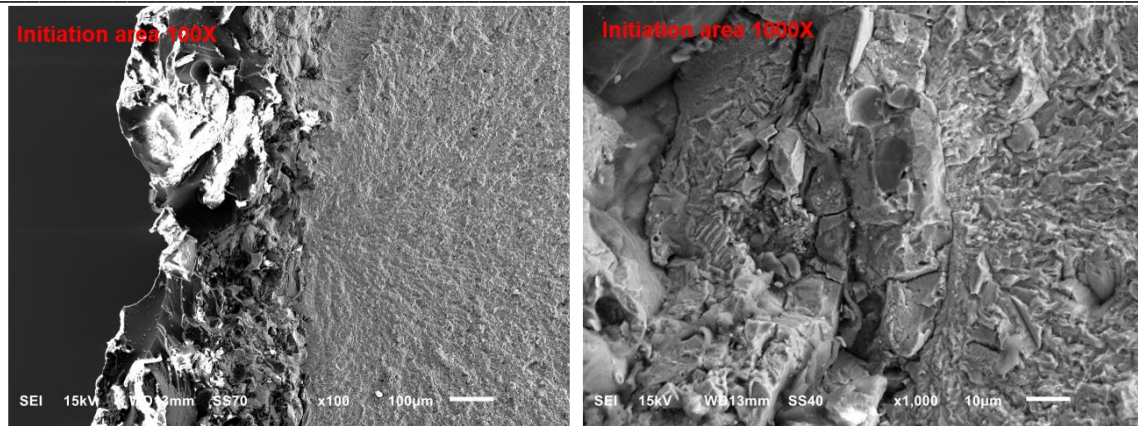
SEM images of the Ti-6Al-4V rod at the crack initiation site are shown in Figure 2. As indicated by the chevron marks that point to the origin of fracture in the 100X images, the crack did indeed originate from the surface of the rod. The Ti-V coating at the initiation area was thinner than it was in non-initiation areas. In this area, the coating was broken up into small particles oriented perpendicular to the coating. Due to the relatively weak bonding between the coating and the substrate, cracks formed at the interface and then grew along the coating. The relatively thin coating in the initiation area was possibly due to pitting corrosion or a preexisting defect in the coating.

Figure 2. SEM images at fatigue crack initiation area, (left) 100X, (right) 1000X.

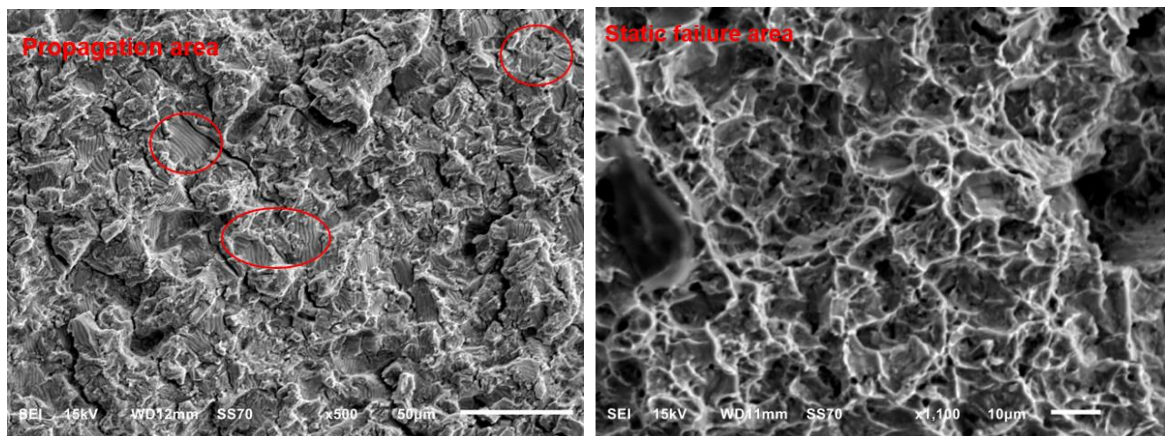
Figure 3 compares the microstructure of the Ti-6Al-4V rod in the crack propagation and static failure areas. In the propagation area, striations were found, or ridges showing the progression of the crack front after each successive loading cycle (red circles, Figure 3). In the static failure area, the surface was rough with dimple microstructures, which is typical of ductile fracture. Shear lips, at roughly 45° angles, were also formed at the edge similar to what was shown in Figure 1.

Figure 3. Microstructure of the fatigue fracture surface of Ti-6V-4Al in propagation (left) and static (right) failure areas.
