## Impact Fracture of a Metallic Hood Ornament

My car's metal hood ornament broke off! Let's figure out what happened.

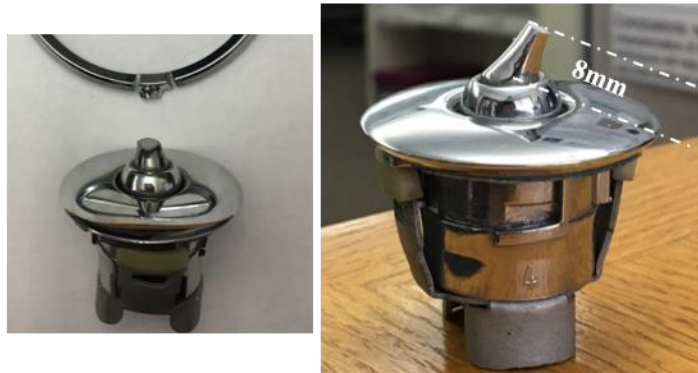
Figure 1. Images of hood ornament after fracture.

Figure 1 shows images after fracture of the metallic hood ornament. To analyze the cause of this fracture, we observed the fracture surface via scanning electron microscopy (SEM). SEM is a powerful tool that can analyze the fracture surface of various materials, including metals, ceramics, and polymers. The examination of surface features via SEM is easy to perform and can clearly identify features as small as 5 nm. This level of spatial resolution, along with an incredible depth of field, makes SEM the preferred method of revealing microstructural detail versus optical microscopy. Combined with x-ray energy dispersive spectroscopy (EDS) or backscattered electron imaging, SEM can even identify element and phase distribution over a sample's fracture surface.

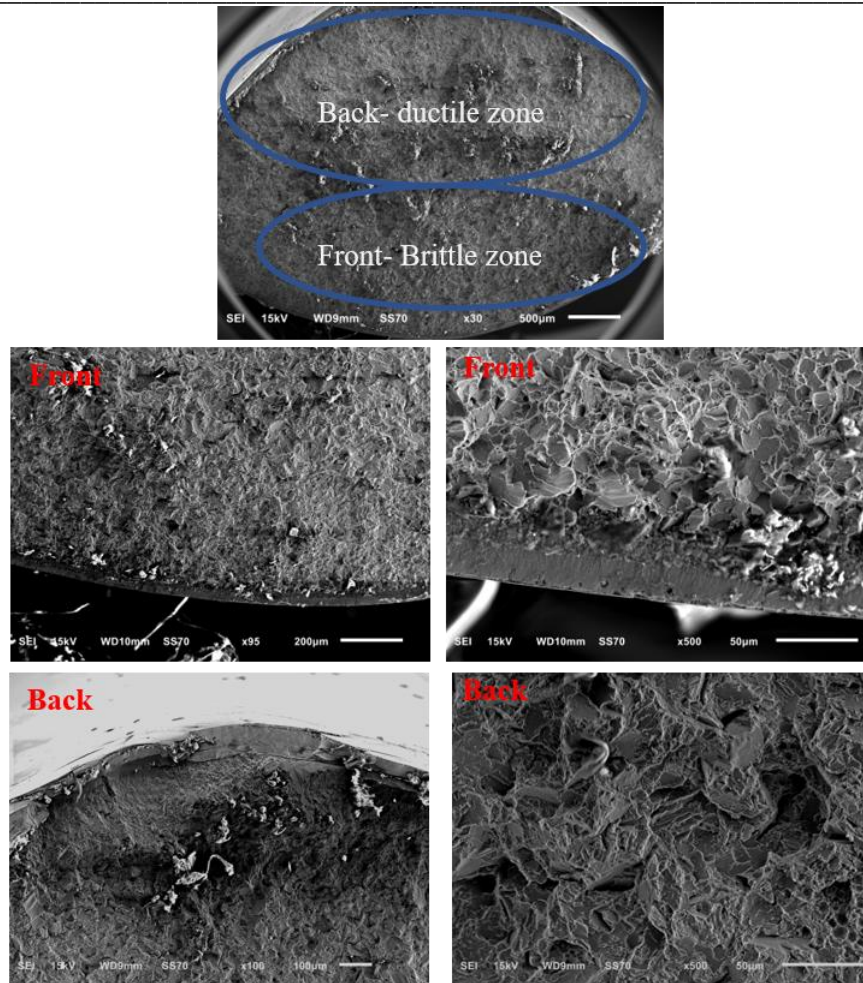
Figure 2 shows SEM images of the front and back fracture surfaces of the hood ornament. The front fracture surface shows a relatively flat morphology, while the back is considerably rougher. At 500X magnification, cleavage lines were observed across the Ni coating, which show the direction of crack propagation. Multiple sources of the cleavage lines mean that the rupture was initiated at several positions. The substrate in the front fracture surface also had cleavage facets or breaks between crystallographic planes. Generally, multiple rupture initiations and cleavage fractures are the hallmarks of brittle fracture. In the center of the fracture area, the fracture surface began to tilt or slope at an angle. Even in the Ni coating, the fracture surface had a small shear lip where the fracture surface was oriented at approximately a 45° angle to the applied stress.

Figure 2. SEM images of the front and back fracture surfaces.

Based upon the differences between the front and back fracture surfaces, the failure was induced by applying a bending force to the emblem. The bending force caused tensile stress to form in the front side of the emblem and compressive stress on the back side. The fracture was initiated near the thinnest part of the front side. Due to this force and the resulting tensile stress on the front side, the fracture surface showed a flat and brittle fracture morphology. The back side of the emblem was in compression and showed a ductile fracture morphology.
