## Low-Cycle Fatigue Failure of Steel Wire

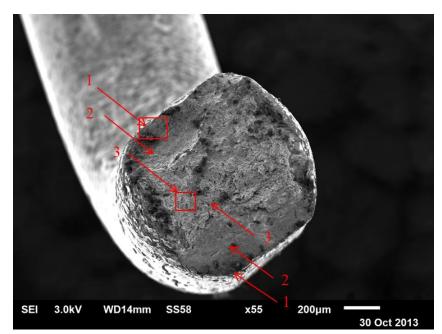
Figure 1. Scanning Electron Microscopy (SEM) image of an fractured steel wire.

Figure 1 illustrates an SEM image obtained by Ebatco NAT Lab's JEOL 6610LV for fracture failure analysis of a steel wire failed under cyclic loading. Bending of the wire back and forth has caused both sides of the wire to undergo compression and tension forces, and the final wire rupture. Arrows marked with 1, 2 and 3 indicate the typical three stages of fatigue failure. Arrows marked with 1 indicate crack initiation regions. Arrows marked with 2 indicate crack propagation regions. Arrows marked with 3 are the final fracture regions.
