Ebatco

Case

Study

Fracture Failure Analysis of Steel Wire

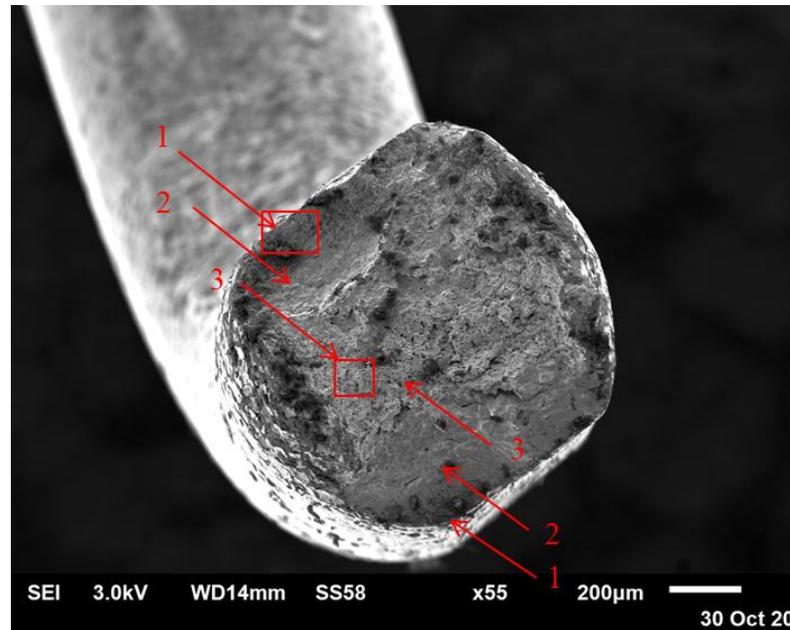
Figure 1. Scanning Electron Microscopy (SEM) image of a fractured steel wire.

Figure 1 illustrates an SEM image obtained by Ebatco NAT Lab's JEOL 6610LV for fracture

failure analysis of a steel wire failed under cyclic loading. Bending of the wire back and forth has caused both sides of the wire to undergo compression and tension forces, and the final wire rupture. Arrows marked with 1, 2 and 3 indicate the typical three stages of fatigue failure. Arrows marked with 1 indicate crack initiation regions. Arrows marked with 2 indicate crack propagation regions. Arrows marked with 3 are the final fracture regions.

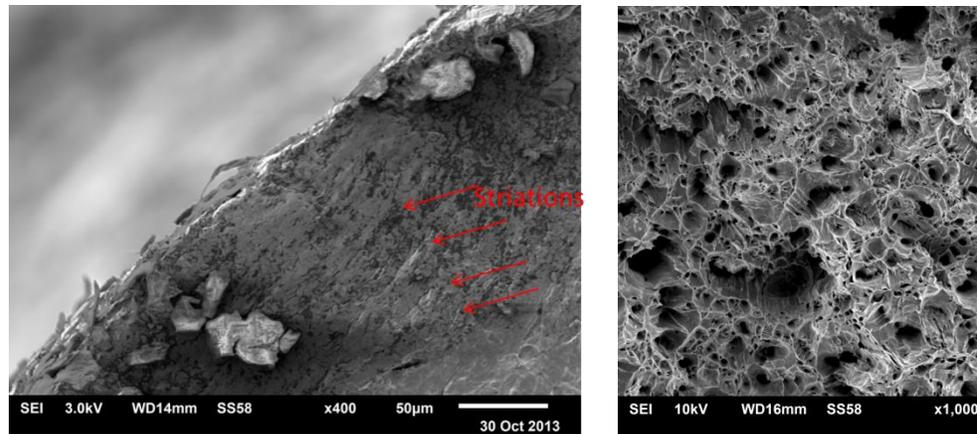
Figure 2 presents higher magnification images of the red rectangles shown in Figure 1. The image below at left shows the area close to the crack initiation region. In this image, the striations as typical fatigue characteristics caused by crack propagation can be easily seen. The image below at right illustrates typical dimple structures from ductile fracture in the final fracture region. The dimples are formed due to high local plastic deformation at final rupture of the wire.

Figure 2. Enlarged fracture areas from Figure 1; left image, rectangular 1; right image, rectangular 3.
