SEM/EDS Analysis of Bicentennial Penny Patina

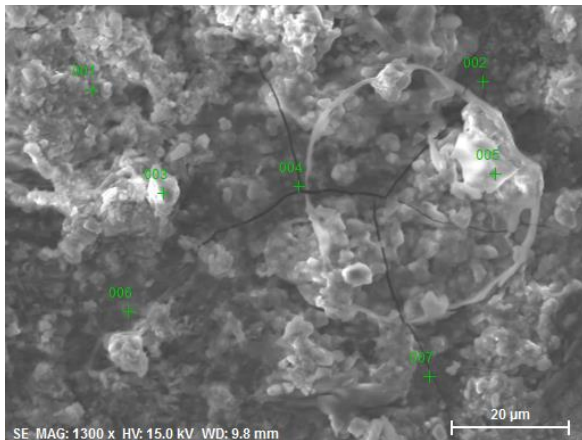
Figure 1. Micrograph image of corroded area, taken with SEM; EDS point analysis locations indicated in green numbers.

From the SEM image, it is obvious that the corroded area has characteristics of severe metal corrosion: uneven, porous and powdery microstructure, and cracks on the surface caused by corrosion stresses. The EDS compositional analysis has indicated that three main elements in the majority of locations are copper, oxygen, and carbon. It is suspected that these elements are existing in the forms of copper (I) carbonate or copper (II) carbonate as the results of penny corrosion. Some small amounts of zinc, the alloying material used in pennies produced between 1962 and 1982, such as the 1976 penny we examined, were also detected in some of the locations. In addition, all analyzed locations show some amounts of chlorine. This could be evidence of copper or zinc chlorides present due to corrosion. Furthermore, the presence of sodium suggests some amount of sodium chloride, likely due to sweat deposited on the surface when handling of the penny.

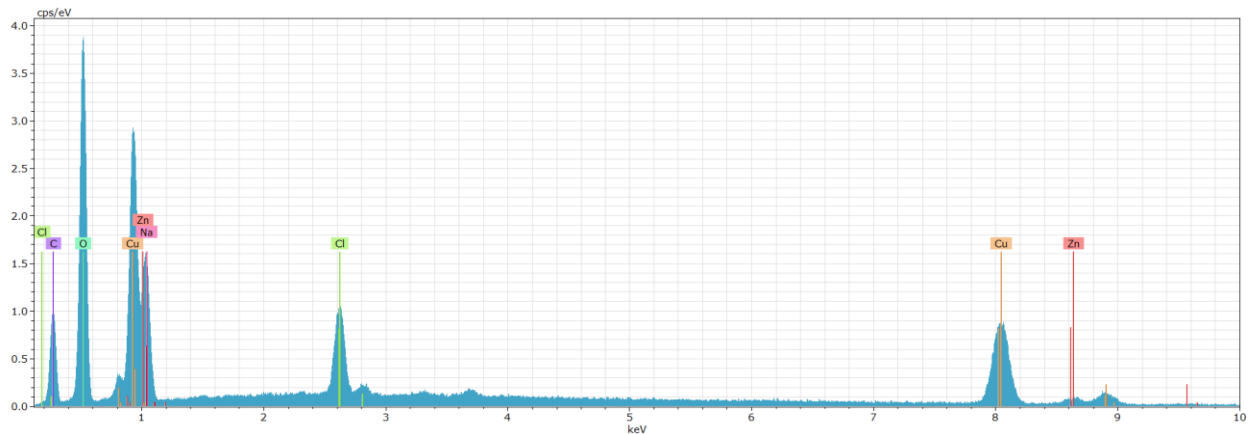
Figure 2. Spectra results of the point analysis at location 001.
