Ebatco Nano

A Bimonthly Newsletter

Vol. 8 | Issue 05
September/October 2018

Tensile Fracture Failure Mechanisms of 316L Stainless Steel

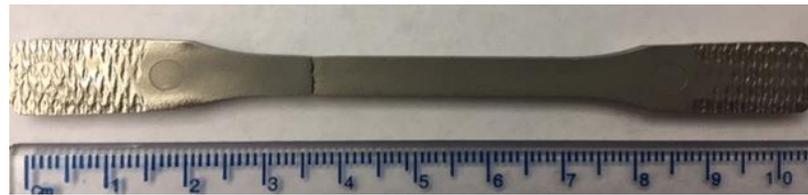
The 316L stainless steel sample was approximately 10.5 cm in length and fractured under tension approximately 4 cm from one of the ends (Figure 1). As can be observed from Figure 1, the cross-section of the fracture is uneven, and slight necking is observed at the fracture position.

Figure 1. Image of the 316L stainless steel bar after tensile fracture.

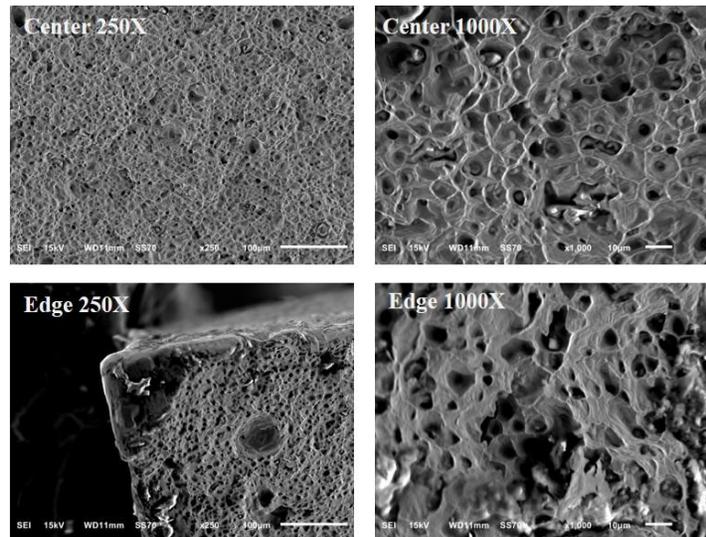
Figure 2. SEM images of the center of the fracture (top) and the edge of the fracture (bottom).

The SEM images in Figure 2 display a rough, dimpled morphology at both the edge and center surfaces, indicative of a ductile fracture. Particles were found at the base of these dimples, and the walls of these dimples had striped microstructures oriented perpendicular to the crack propagation front. Additionally, shear lips at approximately 45° angles were formed at the corners of the fracture. Based on these observations, the fracture was classified as a mixed-mode tensile fracture involving first a plane-strain fracture mode (mode I) and then a plane-stress fracture mode (mode II).

The first fracture mode initiated due to an increase in hydrostatic stress near the center of the sample. Microvoids then formed within the sample and coalesced to form cracks along the plane normal to the tensile load. Taken together, this is characteristic of a plane-strain fracture mode. This is further supported by the striped microstructures observed in the dimples, which suggest the presence of fibrous zones (Figure 2, right). As the propagation cracks approached the edge of the sample, 45° shear lips were formed, and the fracture mode changed from a plane-strain mode to a plane-stress mode (mode II).

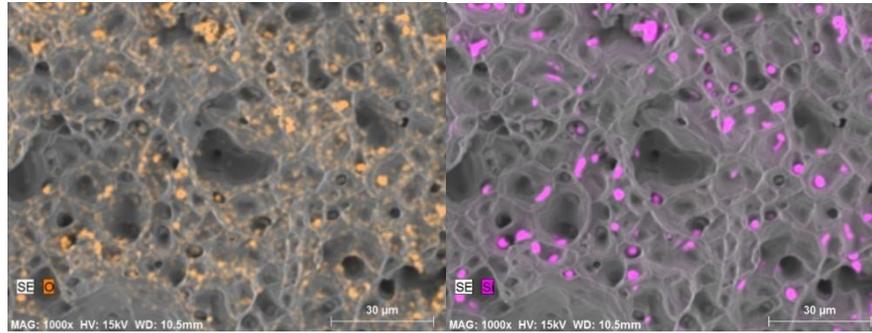
To provide further insight, energy dispersive X-ray spectroscopy (EDS) was also performed on the fracture surface. Figure 3 shows the silicon and oxygen EDS maps on the fracture surface, and the images indicate the particles at the base of the dimples are SiO₂ inclusions. Originating from the stainless-steel manufacturing process, these SiO₂ inclusions must have been present in the initial austenite matrix. When the sample was stressed, the already-present voids near the inclusions grew to form dimpled microstructures around the SiO₂ inclusions. Based on the SEM/EDS analysis, the 316L stainless steel fracture mechanism was a combination of mixed fracture modes (mode I and II). Furthermore, the presence of SiO₂ in the austenite matrix facilitated the growth of microvoids, contributing to the cause of the fracture.

Figure 3. O and Si elemental maps of the 316L stainless steel fracture surface.
