## **Compression Fracture Analysis of a Pellet Press Shaft**

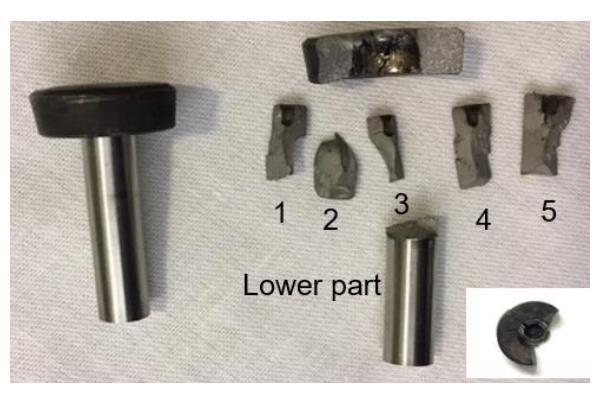
When parts break unexpectedly, determining the root cause is an important step in avoiding future problems. SEM fractography and composition mapping are excellent ways to determine the reasons behind part failures. In this study, a shaft from a pellet press was examined after breaking during routine use. Figure 1 shows the broken shaft compared to an intact shaft. The shaft broke into seven fragments and there was a small black hole at the top center of the shaft. The head of the shaft had a small protrusion which fit into the hole. The shaft was likely connected to the head by a welding or brazing process.

Figure 1. Intact (left) and fractured (right) pellet press shafts.

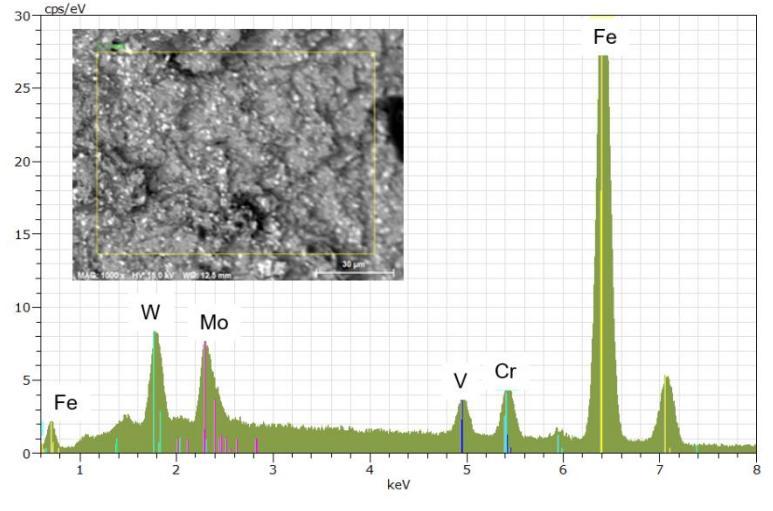
The composition of the shaft was analyzed by X-ray energy dispersive spectroscopy (EDS), the results of which are shown in Figure 2. The EDS spectrum indicates that the shaft was primarily

Figure 2. EDS spectrum of the fracture surface. Inset: SEM image of the corresponding area.

composed of Fe, Cr, W, Mo and V, which are the most common elements used to create tool steels. The bright particles in the SEM image are W, Mo and V carbide particles added to inhibit crack propagation and increase the mechanical strength of the material.

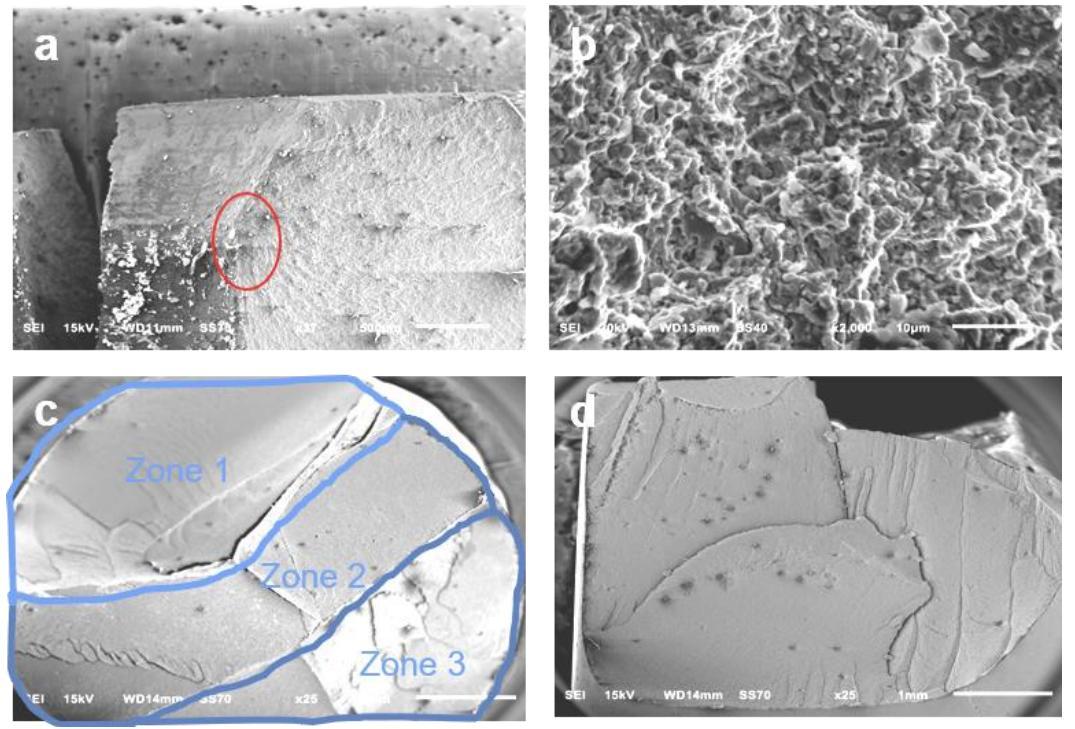
The microstructure of the compression fracture surface was investigated further using SEM (Figure 3). Figure 3a is the SEM image of fragment 5 from Figure 1. In fragment 5, chevron marks, or small lines, are visible which

converge at the crack origination site. Chevron marks were not only observed in fragment 5, but also in fragments 1, 3, and 4. By tracing the chevron marks back, the fracture on fragment 5 originated from the bottom of the hole (red circle, Figure 3a). This location corresponds to the joint area between the shaft and the head, which is an area of high stress concentration. For this shaft fragment, several cracks initiated at the joint area, and the top part of the shaft broke into five pieces. After the crack initiated, the crack propagated downward at approximately 45°, which is

the direction of highest shear stress. This also explains why fragment 2 had two slopes at about 45° angles (not shown).

Figure 3. Fracture surface microstructures. a) SEM image of fragment 5, b) Typical microstructure of the fracture surface at 2000x, c) Top view of the fracture surface on the lower shaft, d) Zone 1 fracture surface.

A typical microstructure of the fracture surface at 2000X magnification is shown in Figure 3b. Pieces 1 through 5 and the lower shaft had similar uneven and dimpled fracture surfaces, characteristic of ductile fracture. Some carbide particles were also found at the base of these dimples. The top view of the lower shafts' fracture surface is shown in Figure 3c. Three unique areas were identified and labeled as zones 1, 2, and 3. Zone 1's fracture surface has a cliff shape (Figure 3d). As shown in Figures 3c and 3d, cleavage lines formed on the fracture surface, demonstrating the growth direction of the cracks. Reassembling the fragments, fragment 2 fitted into zone 1, fragments 1 and 3 fitted into zone 2, and fragments 4 and 5 fitted into zone 3. The slopes on the fragments demonstrated that the cracks grew due to shear stress.

Based on morphological analysis, the fracture was identified as a ductile compression fracture. The cracks initiated at the joint area between the shaft and the head, and grew along the highest shear stress direction. The size and distribution of the carbide particles were homogenous. No large carbide segregation was observed at the critical areas. The failure of the shaft was due to an overload of compressive force.
