Exponential Business and Technologies Company

Scratch Failure Characteristics of DLC Coating on M2 Steel

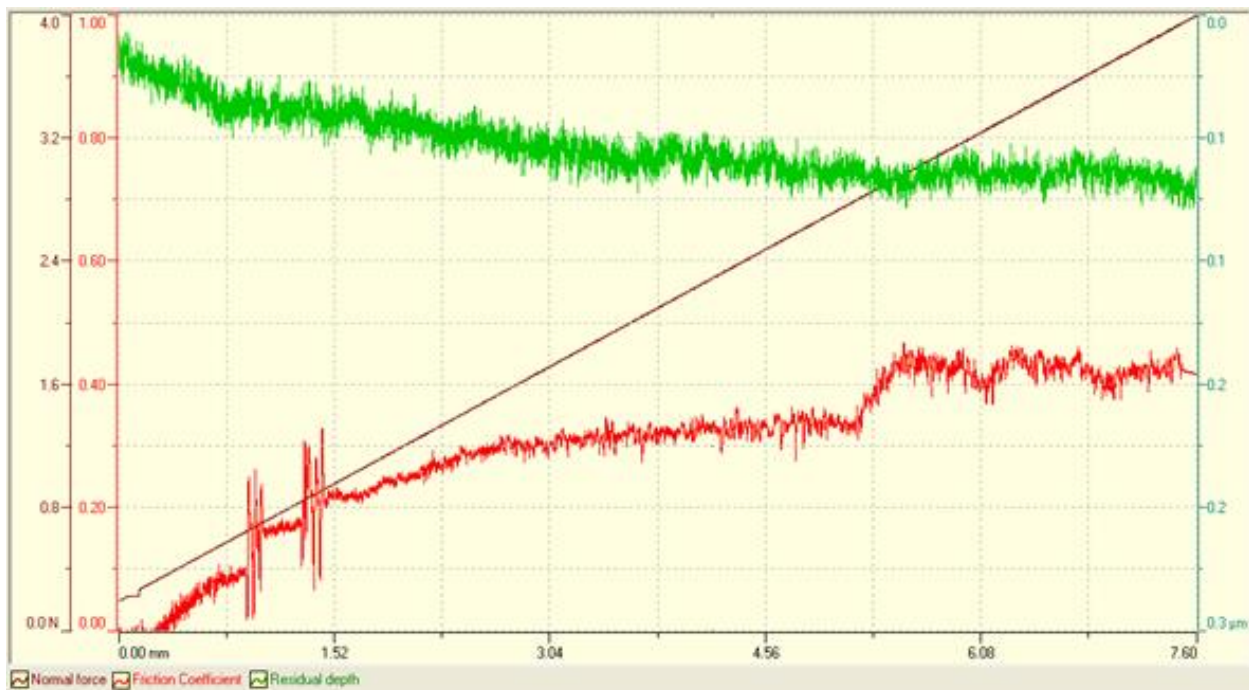
Figure 1. Scratch test data for a DLC coating on M2 steel.

There are a couple of ways to identify critical loads when performing scratch tests. The most common techniques involve monitoring acoustic emission from the sample, looking for changes in coefficient of friction, or viewing the scratch with optical microscopy. From Figure 1, there is a large change in coefficient of friction around the 5.1 mm mark. Figure 2, below, shows the corresponding location of the scratch as viewed from an optical microscope. The failure location corresponds to a critical load of 2.83 N.

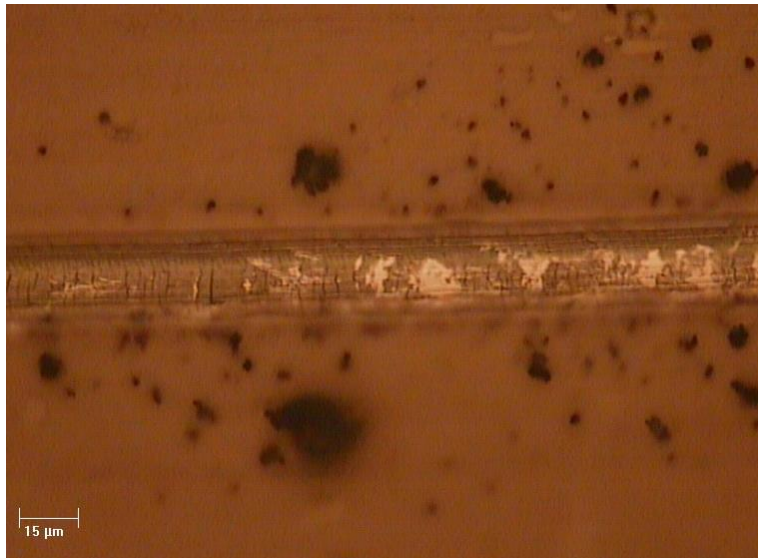
Figure 2. 25x magnified view of the critical failure location in the DLC coating.
