## **Tensile Fracture Failure Mechanisms of 316L Stainless Steel**

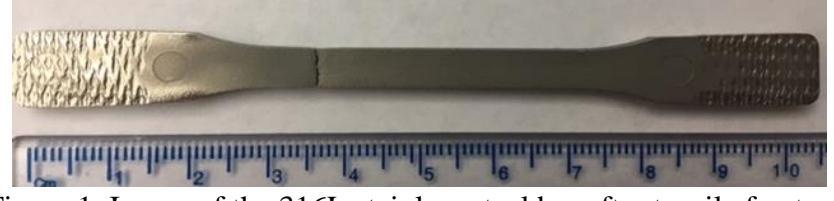
The 316L stainless steel sample was approximately 10.5 cm in length and fractured under tension approximately 4 cm from one of the ends (Figure 1). As can be observed from Figure 1, the cross-section of the fracture is uneven, and slight necking is observed at the fracture position.

Figure 1. Image of the 316L stainless steel bar after tensile fracture.

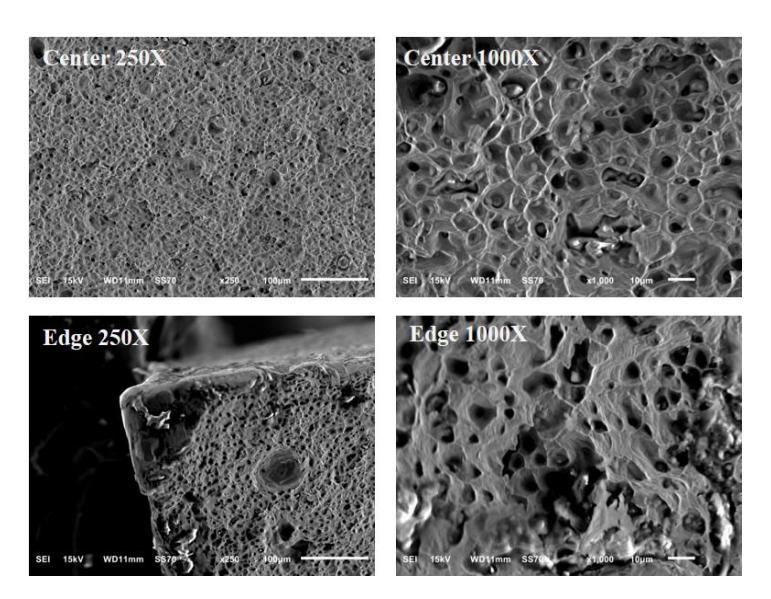
Figure 2. SEM images of the center of the fracture (top) and the edge of the fracture (bottom).

The SEM images in Figure 2 display a rough, dimpled morphology at both the edge and center surfaces, indicative of a ductile fracture. Particles were found at the base of these dimples, and the walls of these dimples had striped microstructures oriented perpendicular to the crack propagation front. Additionally, shear lips at approximately 45° angles were formed at the corners of the fracture. Based on these observations, the fracture was classified as a mixed-mode tensile fracture involving first a plane-strain fracture mode (mode I) and then a plane-stress fracture mode (mode II).

The first fracture mode initiated due to an increase in hydrostatic stress near the center of the sample. Microvoids then formed within the sample and coalesced to form cracks along the plane normal to the tensile load. Taken together, this is characteristic of a plane-strain fracture mode. This is further supported by the striped microstructures observed in the dimples, which suggest the presence of fibrous zones (Figure 2, right). As the propagation cracks approached the edge of the sample, 45° shear lips were formed, and the fracture mode changed from a plane-strain mode to a plane-stress mode (mode II).

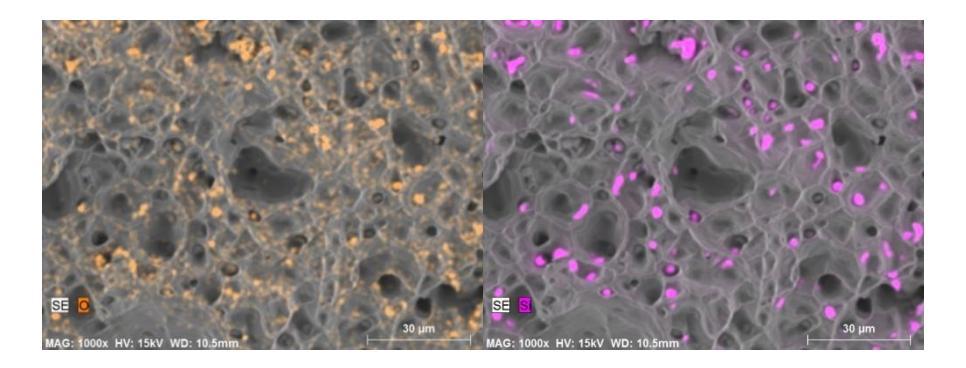
To provide further insight, energy dispersive X-ray spectroscopy (EDS) was also performed on the fracture surface. Figure 3 shows the silicon and oxygen EDS maps on the fracture surface, and the images indicate the particles at the base of the dimples are  $SiO_2$  inclusions. Originating from the stainless-steel manufacturing process, these  $SiO_2$  inclusions must have been present in the initial austenite matrix. When the sample was stressed, the already-present voids near the inclusions grew to form dimpled microstructures around the  $SiO_2$  inclusions. Based on the SEM/EDS analysis, the 316L stainless steel fracture mechanism was a combination of mixed fracture modes (mode I and II). Furthermore, the presence of  $SiO_2$  in the austenite matrix facilitated the growth of microvoids, contributing to the cause of the fracture.

Figure 3. O and Si elemental maps of the 316L stainless steel fracture surface.
