# Ebatco Nano

Vol. 8 | Issue 03  
May/June 2018

### Tensile Fracture Failure Mechanisms of 316L Stainless Steel

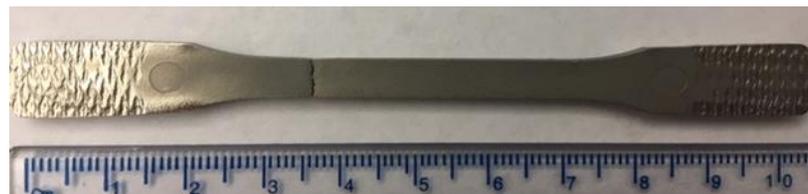
The 316L stainless steel sample was approximately 10.5 cm in length and had been tensile fractured approximately 4 cm from one of the ends (Figure 1). As can be observed from Figure 1, the cross-section of the fracture is uneven, and slight necking is observed at the fracture position.

Figure 1. Image of the 316L stainless steel bar after tensile fracture.

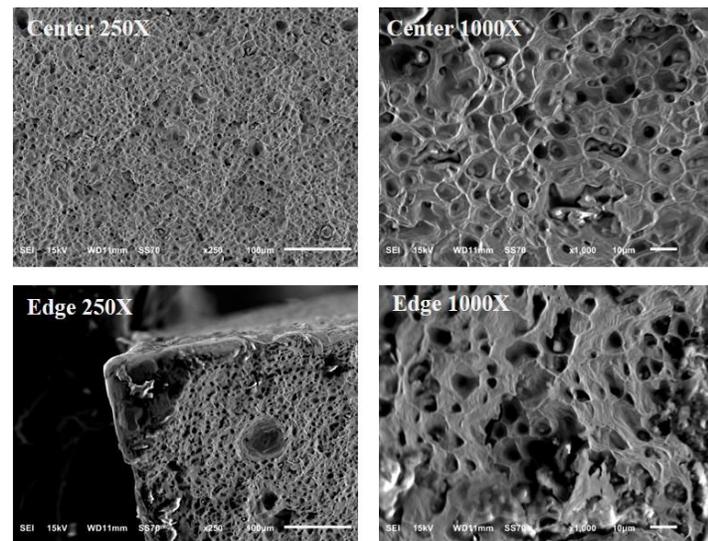
To determine the failure mechanism, the fracture surface was initially analyzed via scanning electron microscopy (SEM). The SEM images at two different magnifications (250x and 1000x) of the center and the edge of the fracture are shown in Figure 2.

The SEM images in Figure 2 display a rough, dimpled morphology at both the edge and center surfaces, indicative of a ductile fracture. Particles were found at the base of these dimples, and the walls of these dimples had striped microstructures oriented perpendicular to the crack propagation front. Additionally, shear lips at approximately 45° angles were formed at the corners of the fracture. Based on these observations, the fracture was classified as a mixed-mode tensile fracture involving first a plain-strain fracture mode (mode I) and then a plane-stress fracture mode (mode II).

Figure 2. SEM images of the center of the fracture (top) and the edge of the fracture (bottom).

The first fracture mode initiated due to an increase in hydrostatic stress near the center of the sample. Microvoids then formed within the sample and coalesced to form cracks along the plane normal to the tensile load. Taken together, this is characteristic of a plane-strain fracture mode. This is further supported by the striped microstructures observed in the dimples, which suggest the presence of fibrous zones (Figure 2, right). As the propagation cracks approached the edge of the sample, 45° shear lips were formed, and the fracture mode changed from a plane-strain mode to a plane-stress mode (mode II).

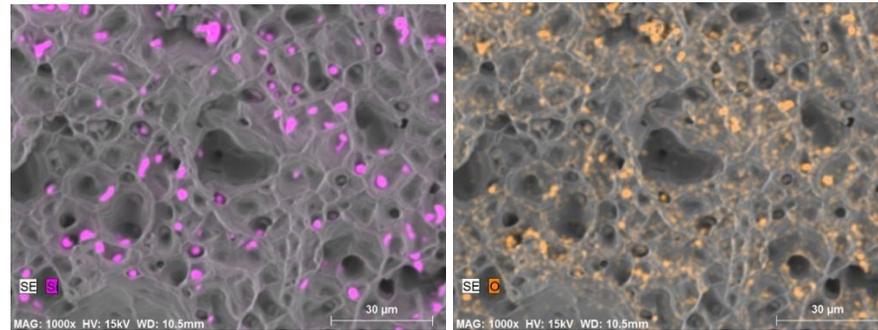
To provide further insight, energy dispersive X-ray spectroscopy (EDS) was also performed on the fracture surface. Figure 3 shows the silicon and oxygen EDS maps on the fracture surface, and the images indicate the particles at the base of the dimples are  $\text{SiO}_2$

inclusions. Originating from the stainless-steel manufacturing process, these SiO<sub>2</sub> inclusions must have been present in the initial austenite matrix. When the sample was stressed, the already-present voids near the inclusions grew to form dimpled microstructures around the SiO<sub>2</sub> inclusions. Based on the SEM/EDS analysis, the 316L stainless steel fracture mechanism was a combination of mixed fracture modes (mode I and II). Furthermore, the presence of SiO<sub>2</sub> in the austenite matrix facilitated the growth of microvoids, contributing to the cause of the fracture.

Figure 3. Si and O elemental maps of the 316L stainless steel fracture surface.
