Ebatco Nano

Vol. 11 | Issue 04
Jul./Aug. 2021

Scratch Failure Test of Automotive Paint Coatings

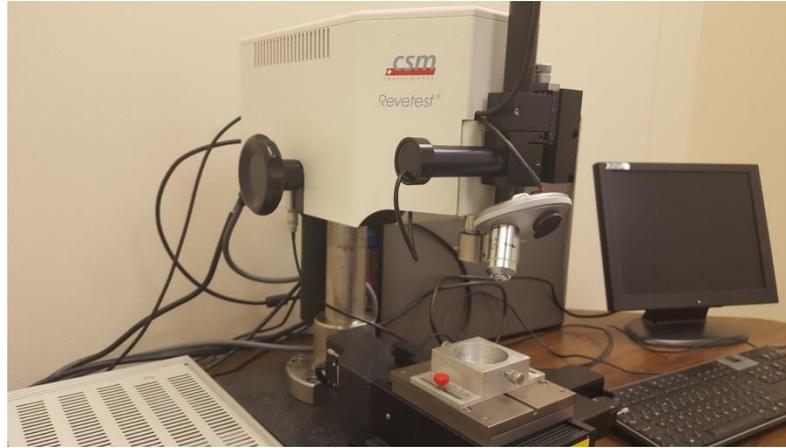
Ebatco newly acquired CSM (now Anton-Paar) Revetest Macro Scratch Tester.

2). To ensure uninterrupted lab services and guaranteed turnarounds for the increasing demand on macroscratch testing, Ebatco has acquired the second CSM (now Anton-Paar) Revetest Macro Scratch Tester. The instrument is capable of making high load (up to 200N) scratches for scratch resistance and coating interfacial adhesion strength evaluation, single-pass and reciprocating friction and wear testing. The instrument is equipped with the panoramic imaging functionality for imaging long scratches at high magnifications. The instrument is very well known for testing hard and relatively-thick film coating materials, such as the ones used in cutting tools and automotive paints. Please feel free to request more information about it or send in your samples to give it a try!

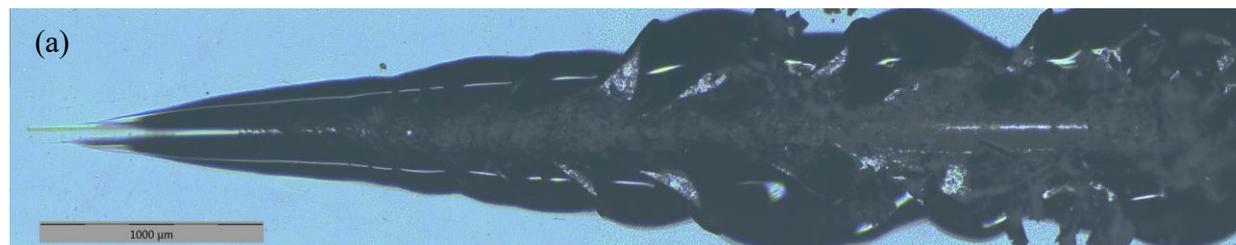
Figure 2. A 5 mm long scratch on automotive paint. A 5x objective lens was used to create a panoramic image of (a) the entire scratch track. A 20x objective was used to image (b) the onset of cohesive cracking in the clear coat layer, (c) the severe cracking of the clear coat layer, (d) the delamination of the clear coat layer from the pigment layer, and (e) the complete coating delamination resulting in exposed substrate.

Figure 1 shows the scratch test results obtained for this automotive paint coating specimen. From Figure 1, it can be seen that there are four critical loads identified based on the analysis of the scratch curves and optical observation of the scratch surface. Figure 2 (a) presents a panoramic image of the corresponding scratch track. The first critical load, 7.51 N, was the force at which cracks started forming in the clear coat, as seen in Figure 2 (b). The second critical load, 9.75 N, was the force at which cracking became more severe, as seen in Figure 2 (c). The third critical load, 12.86 N, was the force at which the clear coat delaminated from the pigment layer, as seen in Figure 2 (d). The fourth critical load, 38.11 N, was the force at which the entire coating system separated from the metal substrate, as seen in Figure 2 (e).
