Ebatco Nano

A Bimonthly Newsletter

Vol. 3 | Issue 06
November/December 2013

Case Study

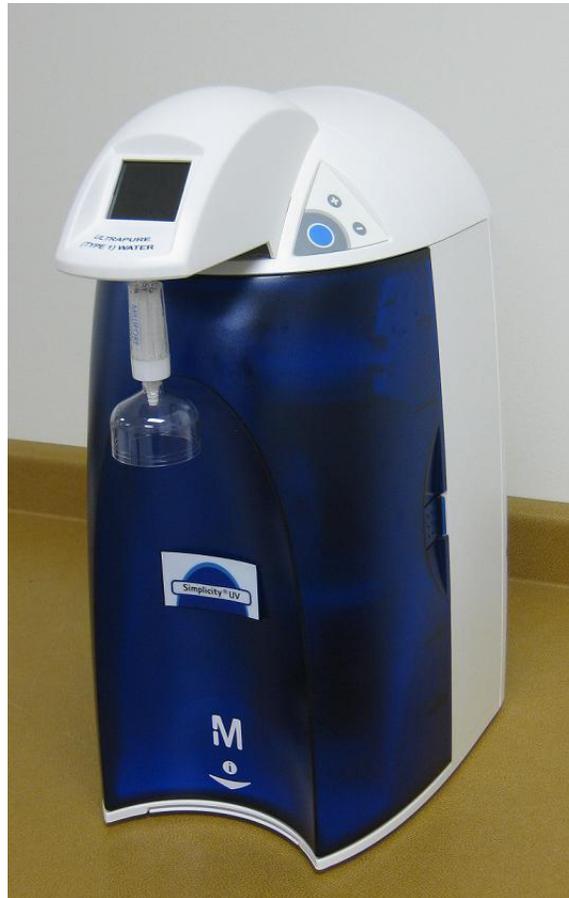
Millipore Simplicity UV Water Purification System.

For tests such as contact angle measurement, particle sizing and Zeta potential, the NAT Lab has had success with distilled water. In most cases, distilled water works well enough, but there are occasions where higher purity water is necessary. For those situations, the NAT Lab has acquired a Millipore Simplicity UV water purification system. The portable Simplicity UV water purification system produces Type 1 ultrapure water. This system will be useful for tests involving instruments such as the NAT Lab's contact angle meters, micro contact angle meter, particle analyzers and surface tensiometers.

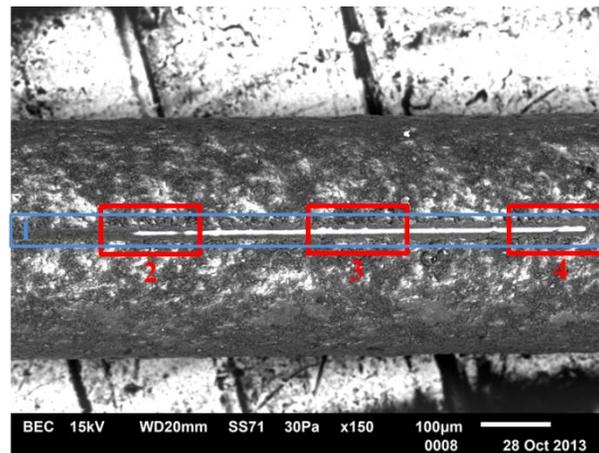
SEM image of a PTFE coated stainless steel guide wire after scratch test; scratch direction: left to right; scratch tip: 2 μ m diameter, cono-spherical diamond tip.

PTFE coated stainless steel guide wires are popular in many medical applications. PTFE coatings are applied to the wire surface for smooth surface finish, reduced friction, increased lubricity and durability of the guide wire. Obviously, the PTFE coating adhesion to the guide wire is critical not only for the desired functionalities but also for the health and safety of the patient to whom the guide wire is to be used. An undesired issue would be flaking of the coating material due to adhesion problems, which could lead to blockage of a passage or clogging of blood vessels. The above figure is an SEM image of a PTFE coated stainless steel guide wire after scratch test. Blue color box Zone 1 includes scratch before interfacial adhesion failure, transitional Zone 2 in which adhesion failure occurred, steady scratch Zone 3 and scratch end Zone 4. The bright scratch track in Zones 2-4 indicates non-existence of the PTFE coating and exposure of the stainless steel substrate.

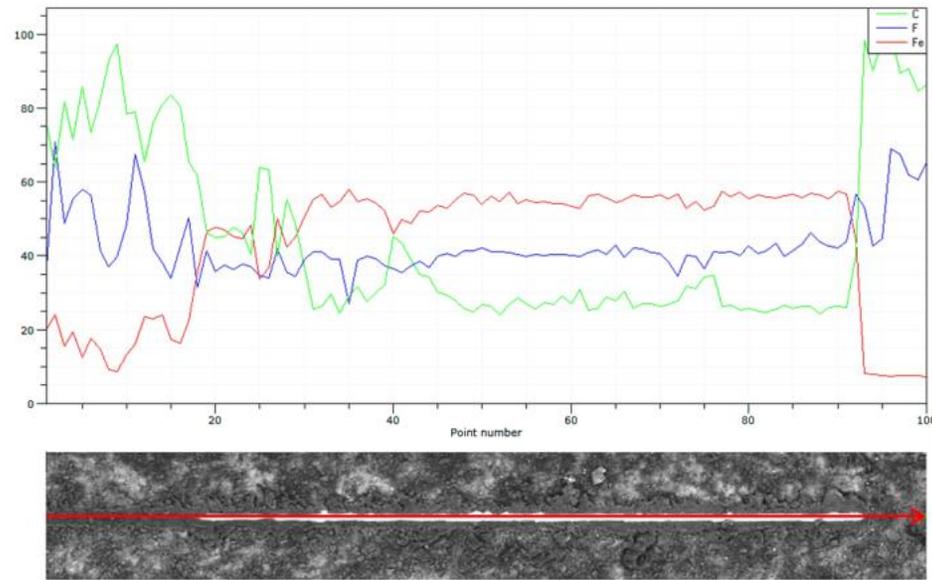
EDS elemental concentration profiles along the red scan line in Zone 1.

The above figure shows the elemental profiles of Zone 1 with the EDS line scanning across the entire scratch. The EDS compositional analysis has verified the morphological interpretations of the SEM image; the coating has in deed delaminated in Zone 2 where element Fe (red line) from stainless steel substrate increases and C (green line) and F (blue line) from the PTFE coating decreases. The zoom-in SEM images and EDS elemental Hypermaps of the Zones 2-4 presented in the figure below provides further details of the elemental distributions of the coating and substrate materials along the scratch.

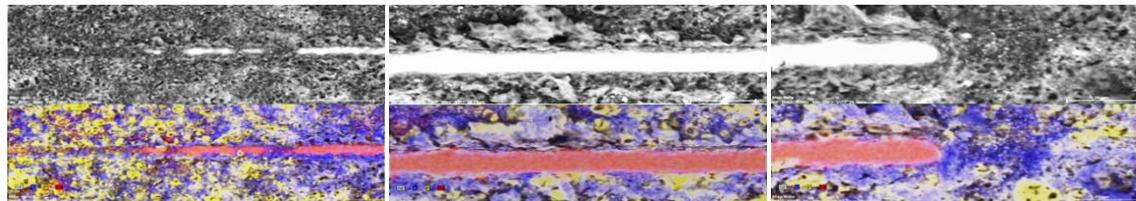
SEM images (top half) and EDS elemental Hypermap (bottom half) of Zones 2-4; C (blue), F (yellow) and Fe (red).
