Ebatco Nano

A Bimonthly Newsletter

Vol. 3 | Issue 05
September/October 2013

Case Study

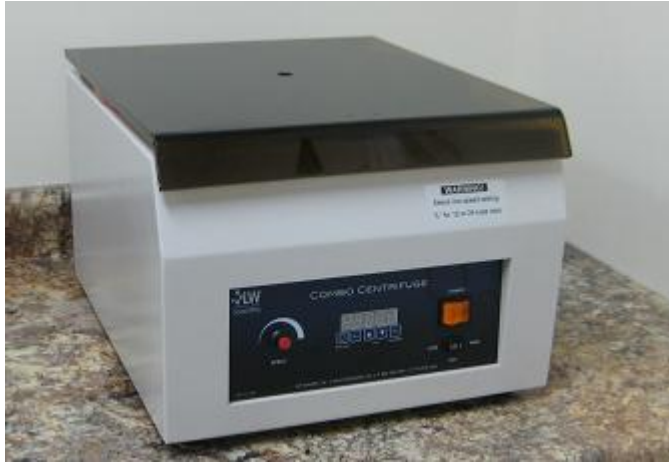
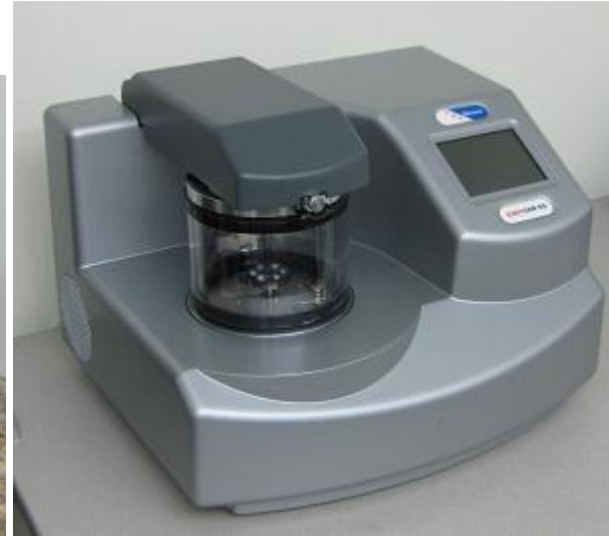
Combo V24 centrifuge (left) and EMS150R ES coater (right).

We have also supplemented our current testing capabilities by acquiring a centrifuge and carbon/metal sputter coater. Our centrifuge is an LW Instruments Combo V24 capable of reaching maximum speeds of 12,000 rpm. The Combo V24 will expand our existing liquid testing techniques such as particle size and liquid surface tension by providing the capability of liquid processing and particle separation. Our carbon/metal sputter coater is an Electron Microscopy Sciences EMS150R ES, which is capable of carbon fiber coating and metal sputter coating of samples. This coater will facilitate our SEM/EDS system to analyze samples that are non-conductive or are electron beam sensitive.
